MOUNT PLEASANT OPERATION

2017 ANNUAL REVIEW
(ANNUAL REHABILITATION REPORT)

Document ID:	MP001-0000-ENV-REP-0002		
Company:	MACH Energy Australia Pty Ltd		
Effective Date:	28 March 2018	Status:	Issued for Use
Approved By:	Klay Marchant	Revision Number:	00

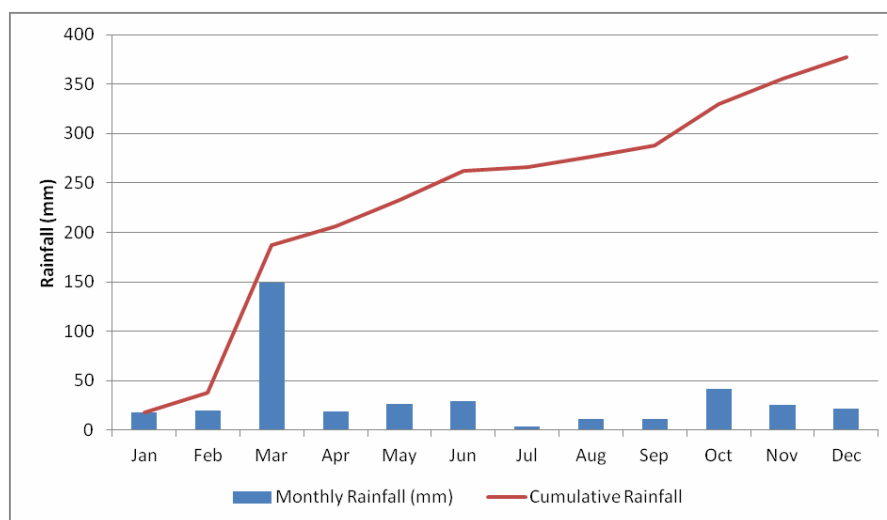
Chart 1: MPO Monthly and Cumulative Rainfall 2017

Jan	Feb	Mar	Apr	May	Jun	Jul	Aug	Sep	Oct	Nov	Dec
Monthly Rainfall (mm)	18.2	19.6	149.6	18.8	26.4	29.8	3.4	11.2	11.2	41.6	25.8	21.8
Cumulative Rainfall (mm)	18.2	37.8	187.4	206.2	232.6	262.4	265.8	277.0	288.2	329.8	355.6	377.4
Wet Days*	3	3	10	4	2	4	0	1	1	3	2	4

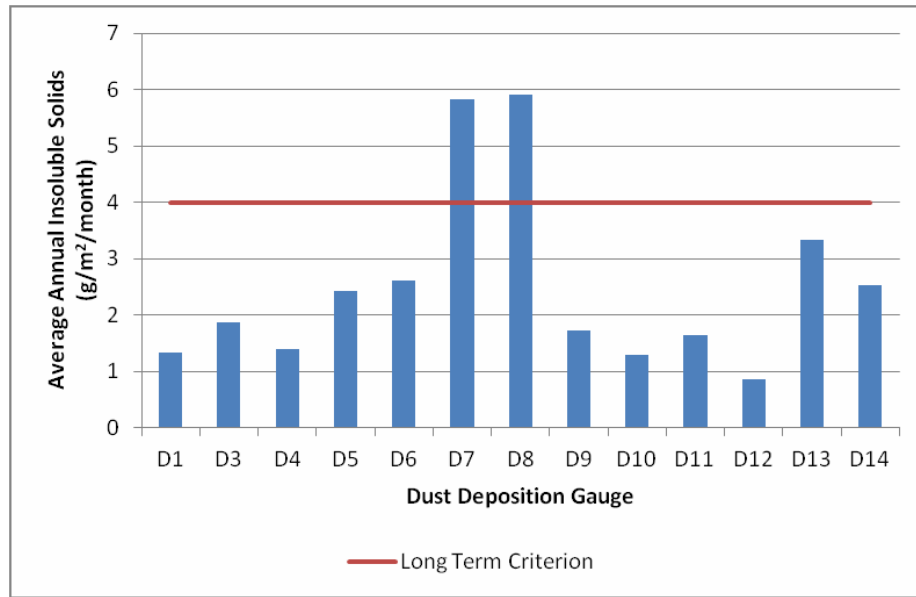
Chart 4: 2017 Annual Average Insoluble Solids

Annual average levels of insoluble solids (i.e. dust deposition) are presented in Chart 4. Chart 5 provides a comparison between annual average dust deposition levels at each of the monitoring sites from 2014 to 2017.

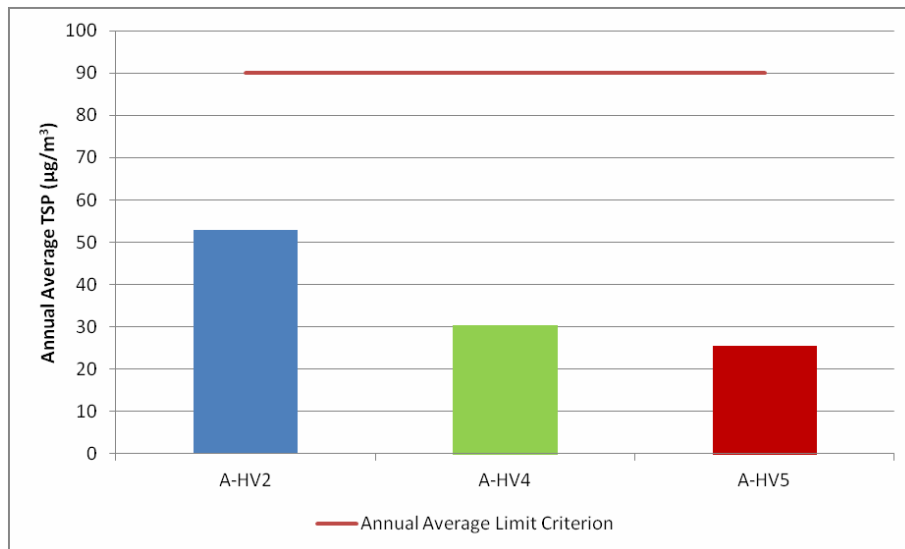
Chart 8: Annual Average TSP Levels

TSP levels were recorded at the three HVAS systems (A-HV2, A-HV4 and A-HV5) located adjacent to the three Palas Fidas monitors (Figure 5). These HVAS systems were sited in conjunction with the Palas Fidas monitors in late 2016. Annual average TSP levels are presented in Chart 8.

The annual average TSP levels were compliant with the annual average TSP criterion during the reporting period.

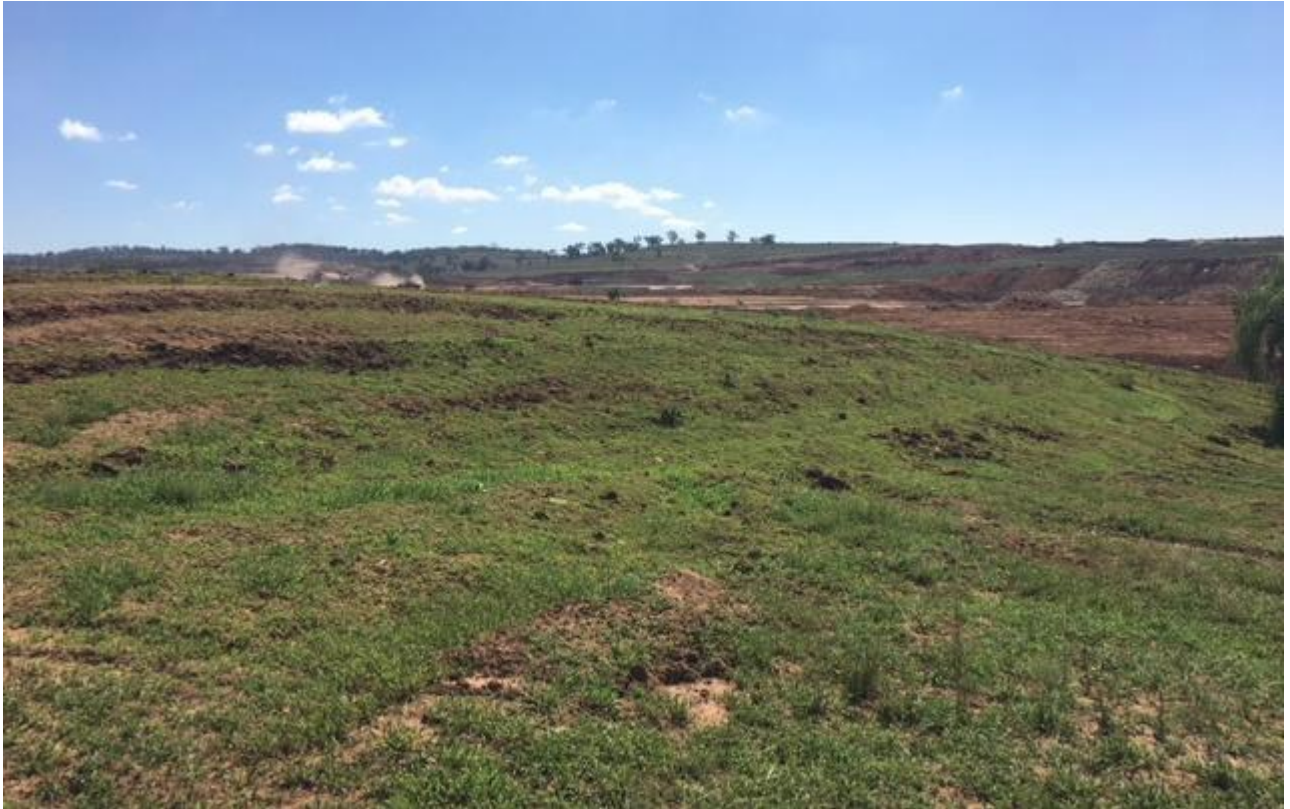
Plate 1 provides an example topsoil stockpile at the MPO. Further descriptions of topsoil stockpile management options are outlined in the approved MOP.

Plate 1: Example Topsoil Stockpile

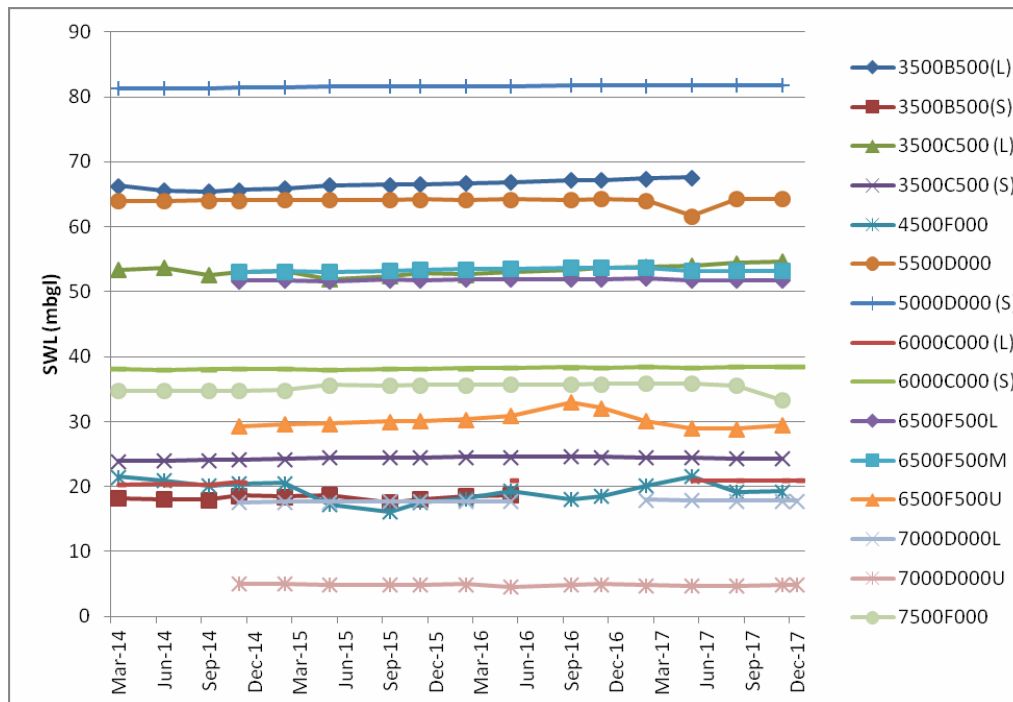
Chart 30: Groundwater Central Bores SWL 2014 – 2017

The results of monitoring SWL (measured in metres below ground level [mbgl], EC and pH from 2014 to 2017 for the groundwater central bores are shown in Charts 30, 31 and 32 respectively.

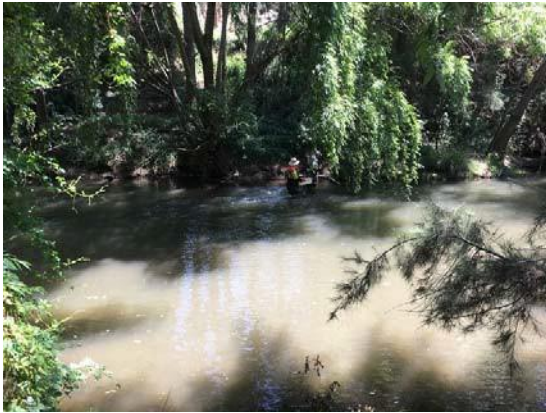
The section of the Hunter River within the study area was classified as Class 1, Type 1 fish habitat according to the DPI (2013) classification. It received an RCE score of 40.

Plate 1: Hunter River – Site HR1 (sp-17)
View across stream
