MOUNT PLEASANT OPERATION

2018 ANNUAL REVIEW (ANNUAL REHABILITATION REPORT)

Document ID:	00967870		
Company:	MACH Energy Australia Pty Ltd		
Effective Date: 29 March 2019		Status:	Issued for Use
Approved By:	Richard Bailey	Revision Number:	00

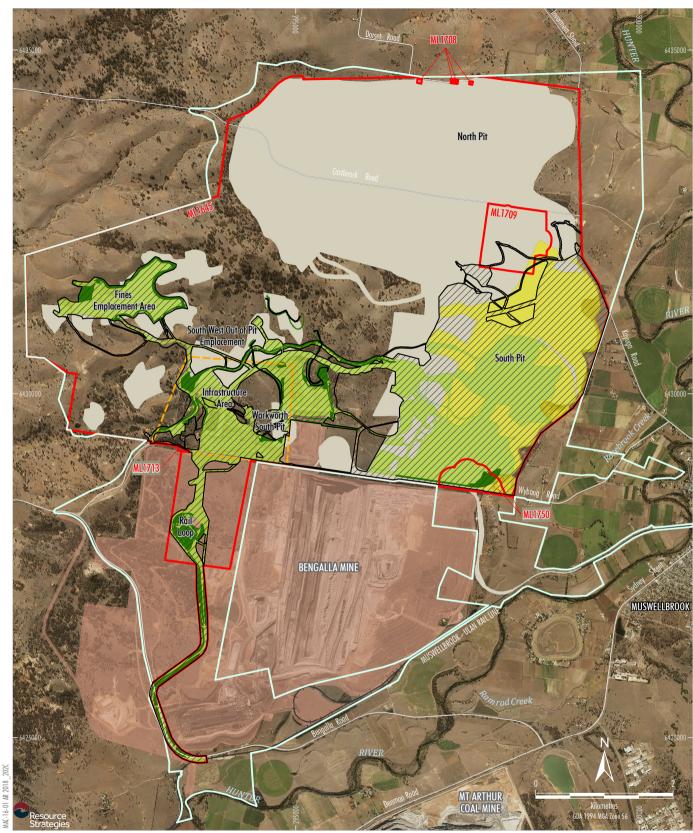
Figure 2 shows the general arrangement of the MPO, as well as the extent of disturbance and rehabilitation at the end of 2018 and the forecasted additional disturbance proposed in 2019.

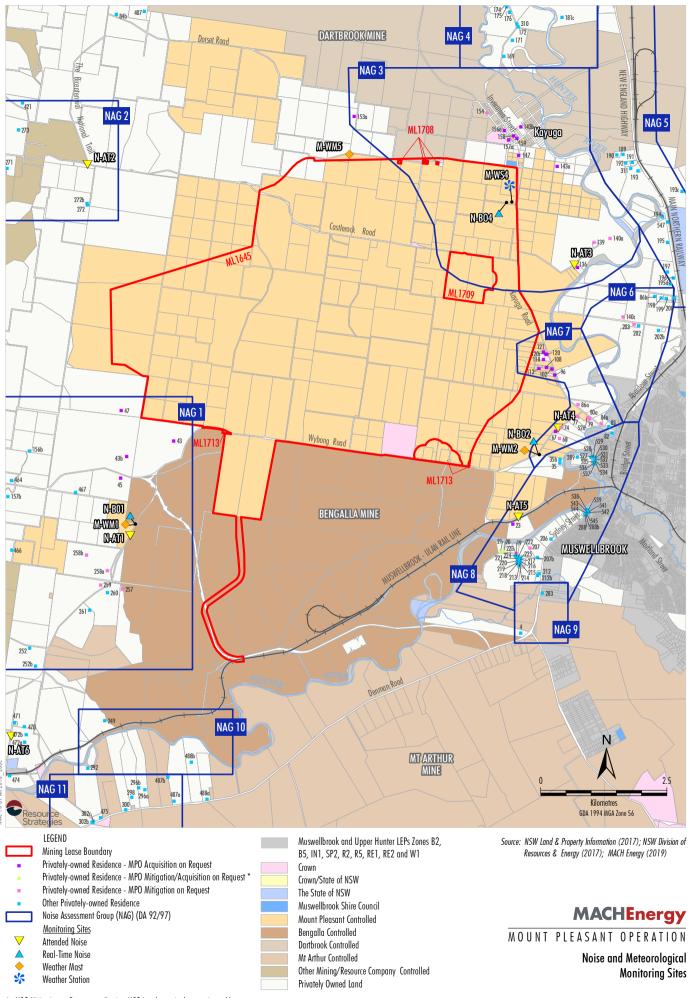
Figure 3

Meteorological monitoring was undertaken during the reporting period at the mine meteorological station along Kayuga Road (M-WS4) (Figure 3). Data collected included 10 minute, hourly and 24 hourly wind speed, wind direction, sigma, temperature, humidity solar radiation and rainfall measurements. Data collected during the reporting period has been summarised for rainfall, temperature and wind in the following subsections.

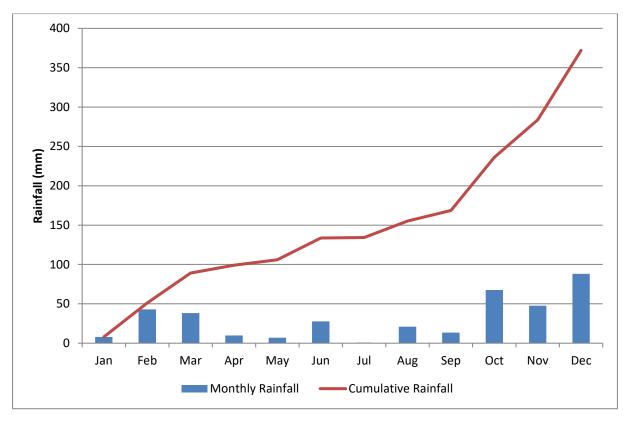
Jan	Feb	Mar	Apr	May	Jun	Jul	Aug	Sep	Oct	Nov	Dec
Monthly Rainfall (mm)	8.0	43.0	38.2	9.8	7.0	27.6	0.6	21.0	13.4	67.6	47.6	88.2
Cumulative Rainfall (mm)	8.0	51.0	89.2	99.0	106.0	133.6	134.2	155.2	168.6	236.2	283.8	372.0
Wet Days*	1	3	5	1	1	3	0	3	3	5	4	6

Chart 1: MPO Monthly and Cumulative Rainfall 2018

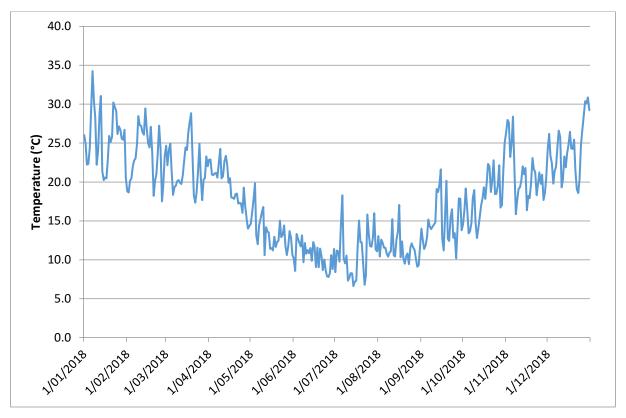
Jan	Feb	Mar	Apr	May	Jun	Jul	Aug	Sep	Oct	Nov	Dec
Minimum Temperature (°C)	11.1	13.2	10.2	8.3	2.0	-0.6	-2.4	0.5	2.7	6.3	9.0	11.3
Maximum Temperature (°C)	41.3	38.1	37.9	32.5	26.4	19.8	23.8	23.2	30.8	34.2	37.7	39.5

Chart 2: MPO Daily Mean Temperature 2018

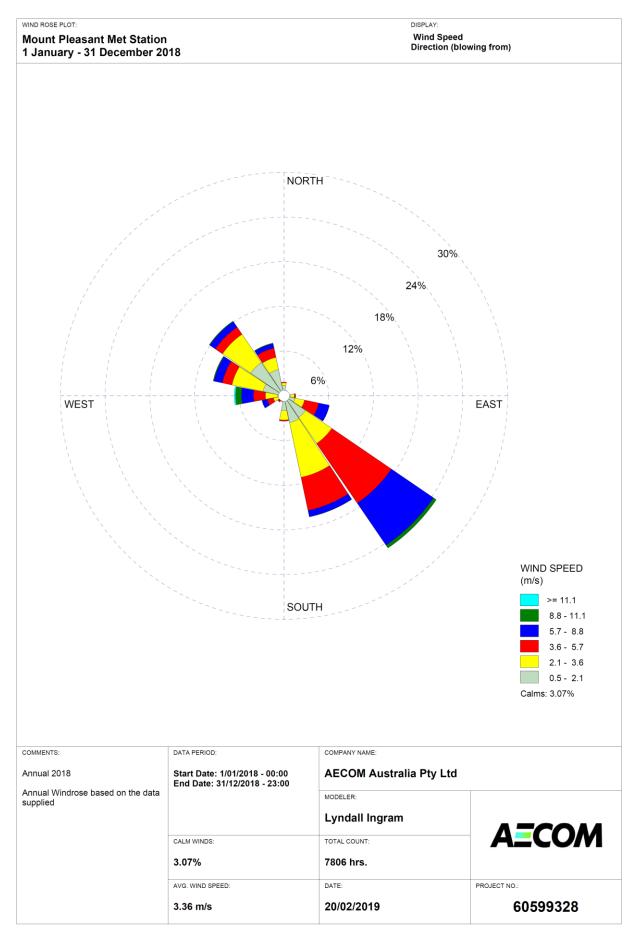
During the reporting period, the majority of prevailing winds were from the south-southeast and north-west. Only a very minor percentage of winds were generated from the south-west and almost none were generated from the north-east. This is consistent with trends observed in previous Annual Reviews (Coal & Allied, 2014, 2015 and 2016; MACH Energy, 2017b; MACH Energy, 2018). An annual wind rose is presented in Chart 3.

Chart 3: MPO Annual Wind Rose 2018

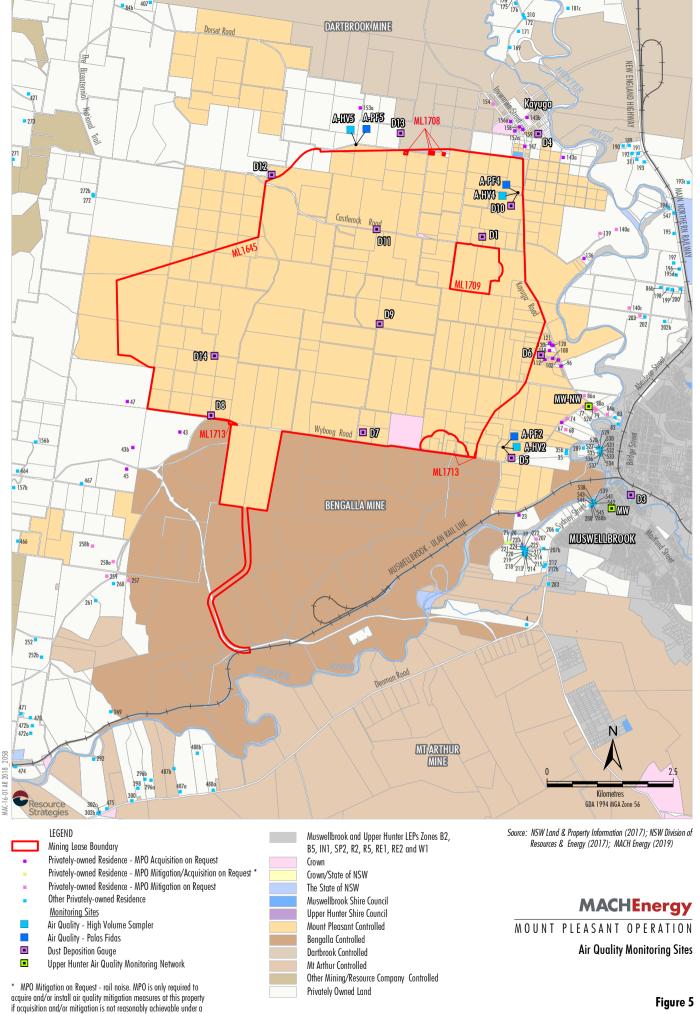
Figure 5

During the reporting period, dust deposition levels were collected at 13 dust deposition gauges situated around the MPO boundary (Figure 5). The gauges were sited in accordance with AS 3580.1.1:2007 and analysed for mass of total insoluble matter and ash in accordance with AS 3580.10.1-2003.

Palas Fidas monitoring systems were installed at three locations (Figure 5) in late 2016. The Palas Fidas systems collected PM_{10} and $PM_{2.5}$ data continuously, which was averaged over 24 hours (Chart 6 and Chart 7) and annually (Chart 8 and Chart 9). One of the Palas Fidas units (APF4) was under maintenance for several months of 2018, and was temporarily replaced by a tapered element oscillating microbalance (TEOM) unit.

TSP levels were recorded at the three High Volume Air Sampler (HVAS) systems (A-HV2, A-HV4 and A-HV5) located adjacent to the three Palas Fidas monitors (Figure 5). These HVAS systems were sited in conjunction with the Palas Fidas monitors in late 2016. Annual average TSP levels are presented in Chart 10.

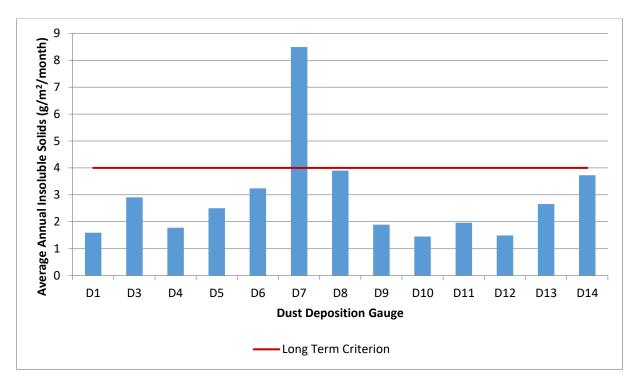
Annual average levels of insoluble solids (i.e. dust deposition) are presented in Chart 4. Chart 5 provides a comparison between annual average dust deposition levels at each of the monitoring sites from 2014 to 2018.

Chart 4: 2018 Annual Average Insoluble Solids

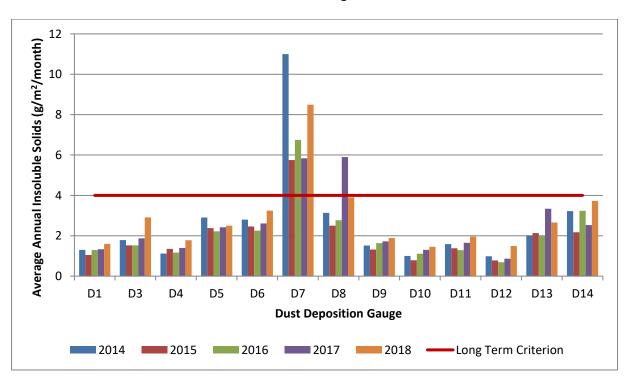
Chart 5: 2014 - 2018 Annual Average Insoluble Solids

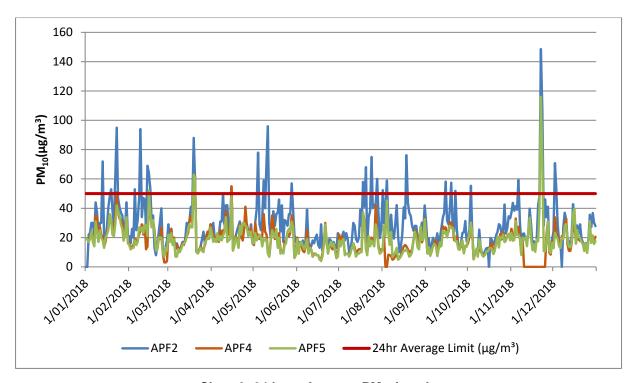
Chart 6: 24 hour Average PM₁₀ Levels

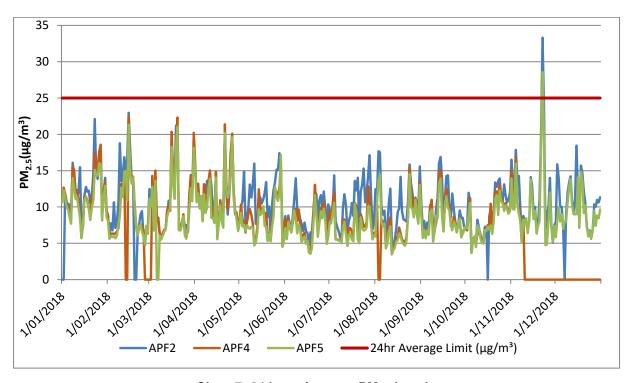
Chart 7: 24 hour Average PM_{2.5} Levels

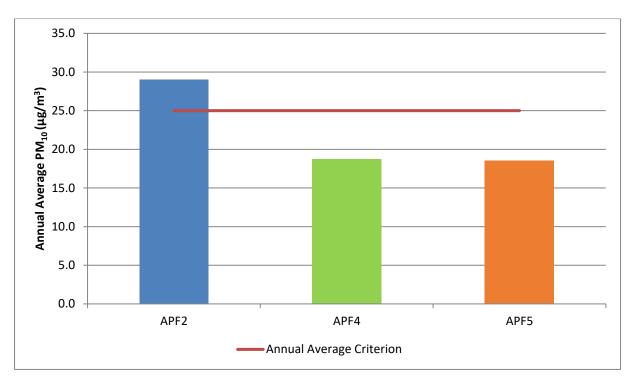
Chart 8: Annual Average PM₁₀ Levels

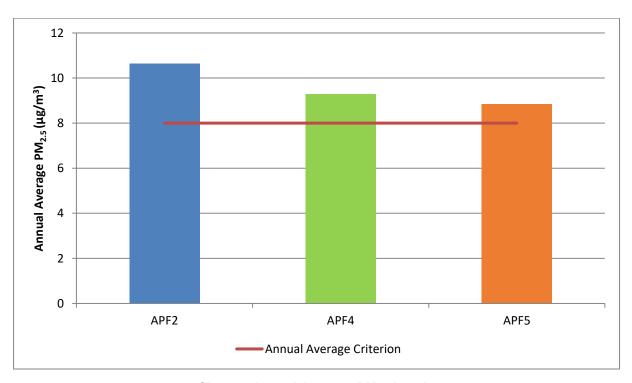
Chart 9: Annual Average PM_{2.5} Levels

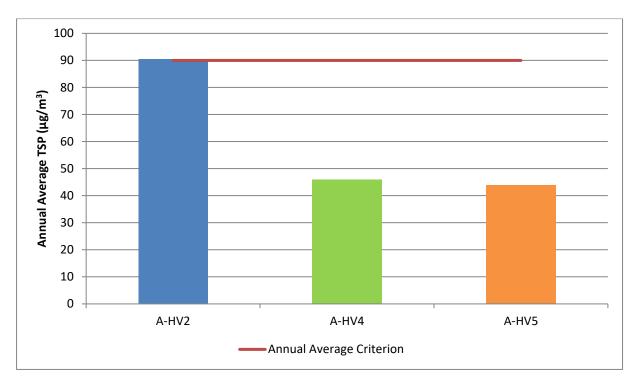
Chart 10: Annual Average TSP Levels

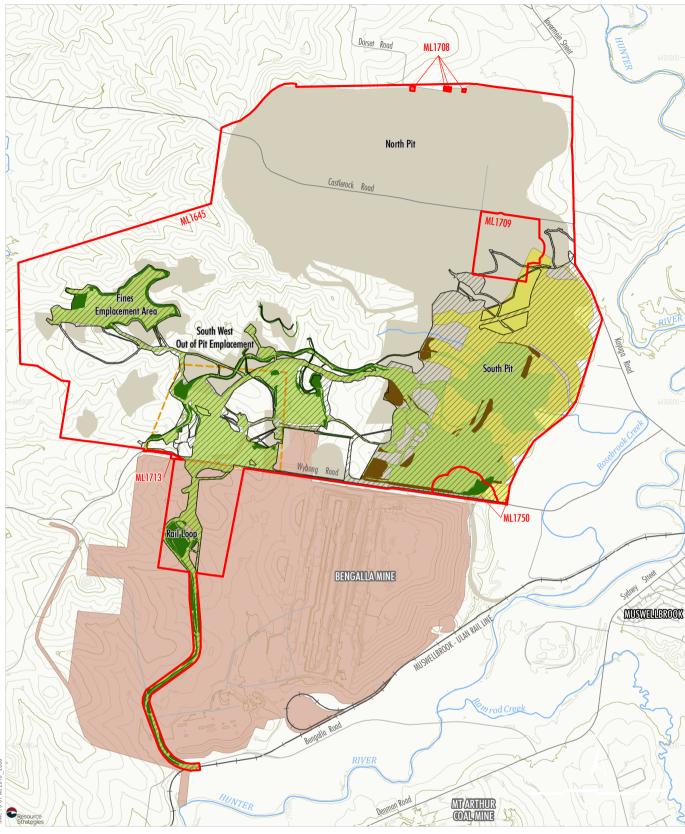
During the reporting period, topsoil stockpiles were located adjacent to active disturbance areas including Pit A and D and areas to be rehabilitated, as shown on Figure 6. A total of approximately 297,700 m³ of topsoil was stored in stockpiles during the reporting period. A topsoil register with individual volumes for each stockpile is kept and maintained on-site.

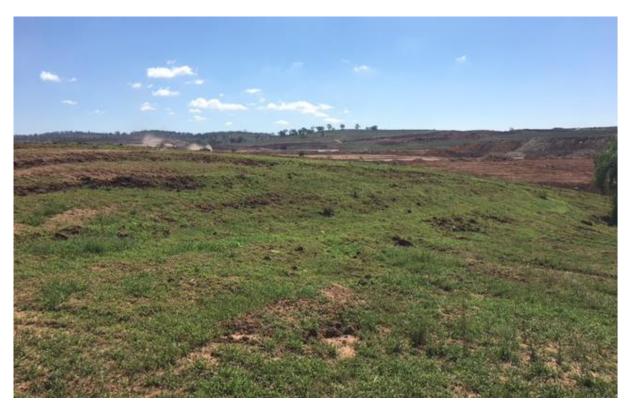
Topsoil is stripped ahead of disturbance activities and where possible, placed onto rehabilitation areas immediately. Where it is impractical to respread topsoil immediately, topsoil is stockpiled, sign posted, and seeded with a cover crop (e.g. native grass) where the stockpile will be in place for greater than 3 months. The topsoil stockpiles are managed to maintain seed reserves and microbial soil associations.

Plate 1 provides an example topsoil stockpile at the MPO. Further descriptions of topsoil stockpile management options are outlined in the approved MOP.

Plate 1: Example Topsoil Stockpile

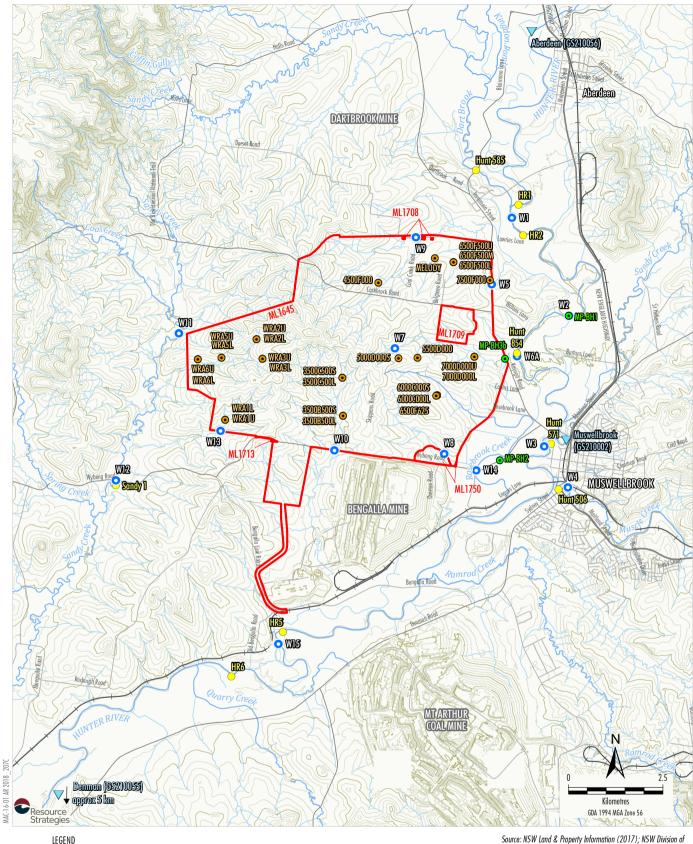
Trigger levels for the remaining water monitoring sites (i.e. W11-W15 [Figure 7]) will also be established once sufficient monitoring data has been collected at these sites.

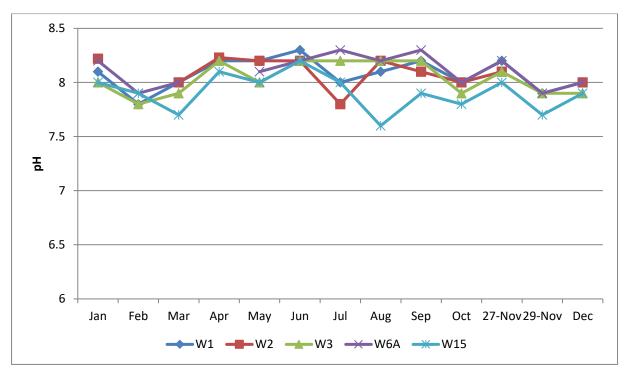
Monitored pH values for the Hunter River monitoring sites during the reporting period are shown in Chart 11. Additionally, a comparison between 2016, 2017 and 2018 pH values is provided in Chart 12.

Chart 11: Hunter River pH Levels 2018

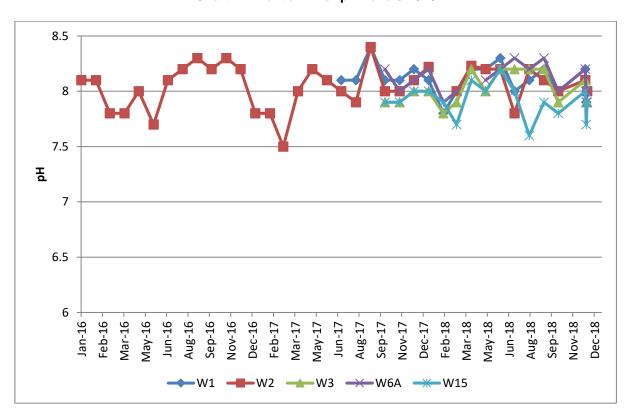
Chart 12: Hunter River pH Levels 2016 - 2018

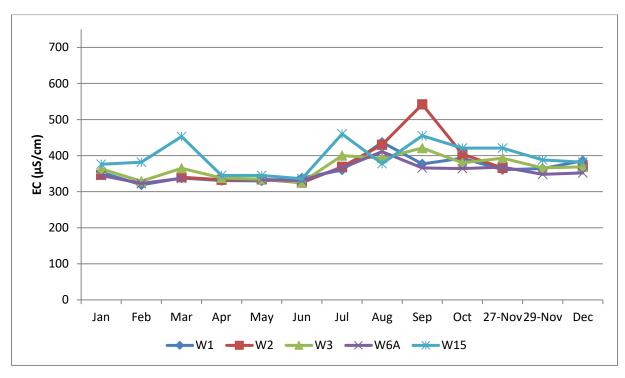
EC values for the 2018 monitoring period are shown in Chart 13. Additionally, a comparison between 2016, 2017 and 2018 EC values is provided in Chart 14.

Chart 13: Hunter River EC Levels 2018

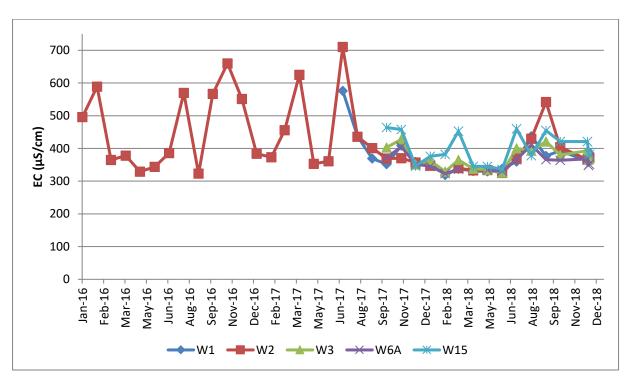
Chart 14: Hunter River EC Levels 2016 - 2018

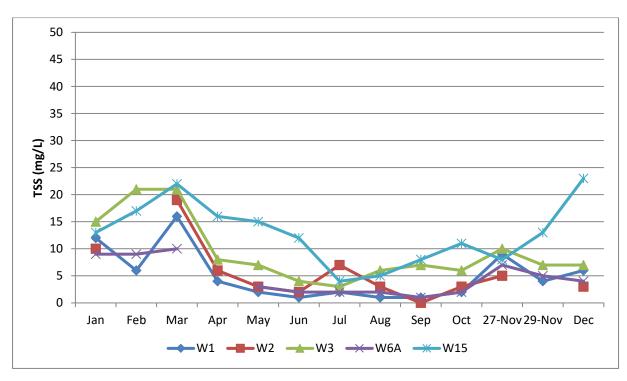
TSS values for the 2018 monitoring period are shown in Chart 15. Additionally, a comparison between 2016, 2017 and 2018 TSS values is provided in Chart 16.

Chart 15: Hunter River TSS Levels 2018

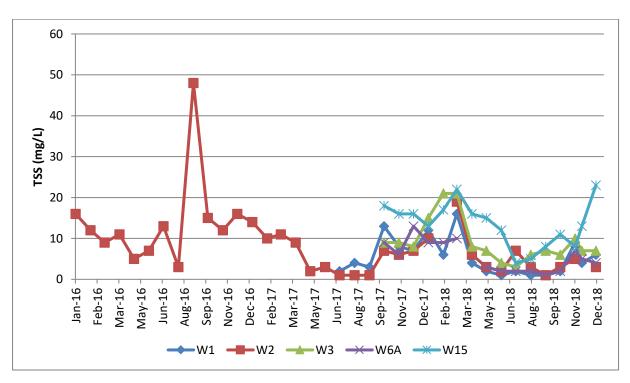
Chart 16: Hunter River TSS Levels 2016 - 2018

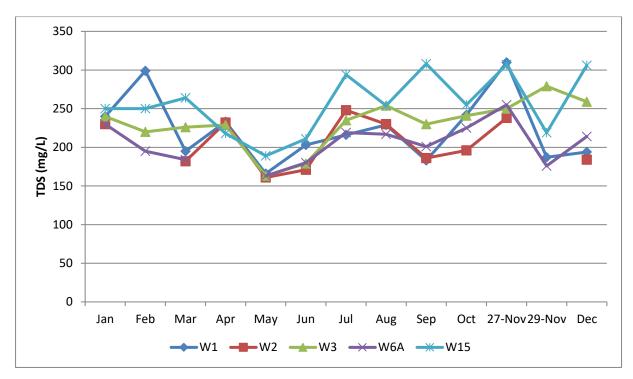
TDS values for the 2018 monitoring period are shown in Chart 17. As TDS monitoring commenced in 2018, there is insufficient data to undertake a long-term comparison of the values.

Chart 17: Hunter River TDS Levels 2018

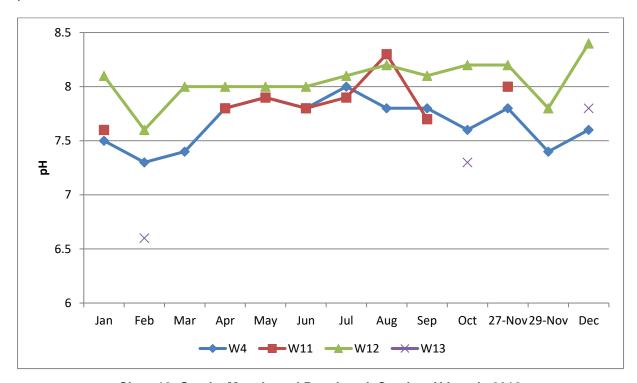
Monitored pH values for the Sandy, Muscle and Rosebrook Creek monitoring sites during the reporting period are shown in Chart 18. Additionally, a comparison between 2016, 2017 and 2018 pH values is provided in Chart 19.

Chart 18: Sandy, Muscle and Rosebrook Creeks pH Levels 2018

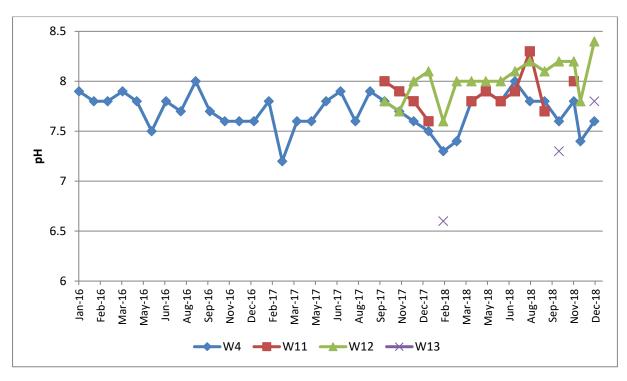
Chart 19: Sandy, Muscle and Rosebrook Creeks pH Levels 2016 - 2018

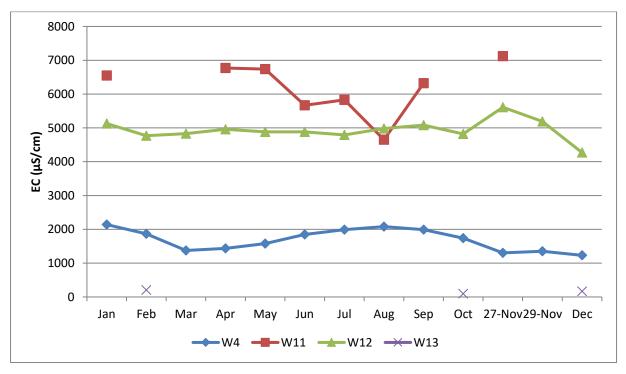
EC values for the 2018 monitoring period are shown in Chart 20. Additionally, a comparison between 2016, 2017 and 2018 EC values is provided in Chart 21.

Chart 20: Sandy, Muscle and Rosebrook Creeks EC Levels 2018

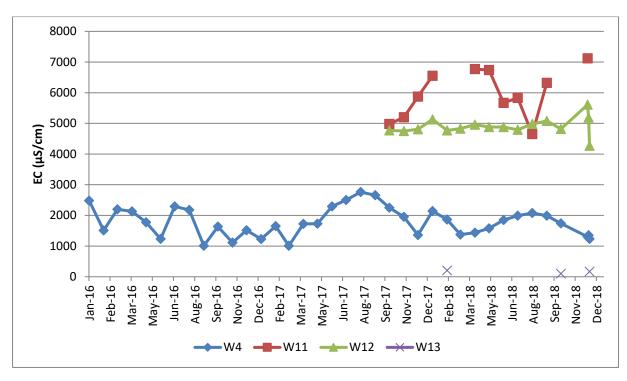
Chart 21: Sandy, Muscle and Rosebrook Creeks EC Levels 2016 - 2018

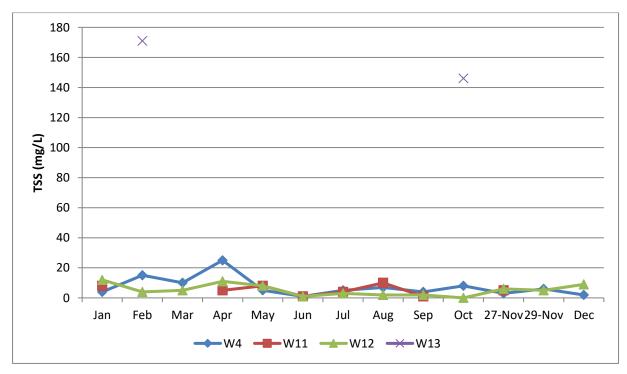
TSS values for the 2018 monitoring period are shown in Chart 22¹. Additionally, a comparison between 2016, 2017 and 2018 TSS values is provided in Chart 23.

Chart 22: Sandy, Muscle and Rosebrook Creeks TSS Levels 2018

An elevated TSS sample was obtained from W13 in December 2018, where a turbid sample was obtained from pooled water. This sample is not shown on Charts 22 and 23.

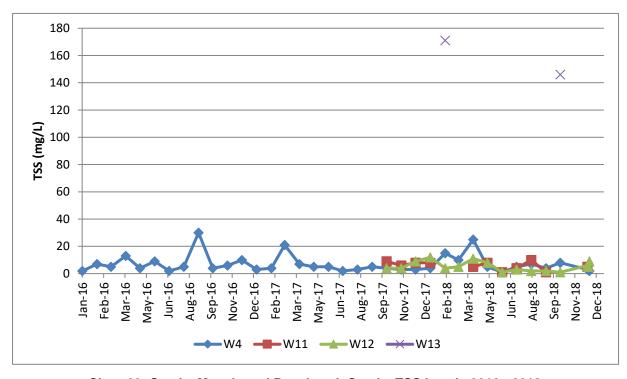
Chart 23: Sandy, Muscle and Rosebrook Creeks TSS Levels 2016 - 2018

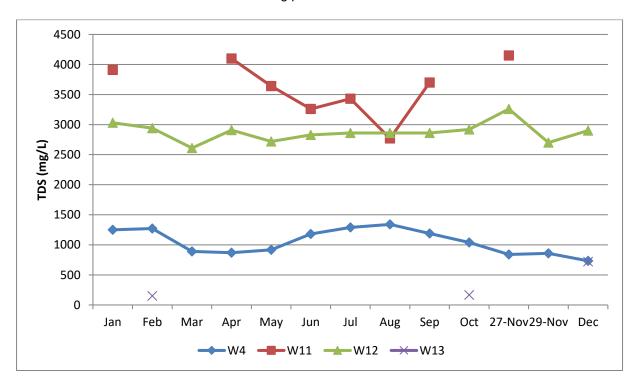
Chart 24: Sandy, Muscle and Rosebrook Creeks TDS Levels 2018

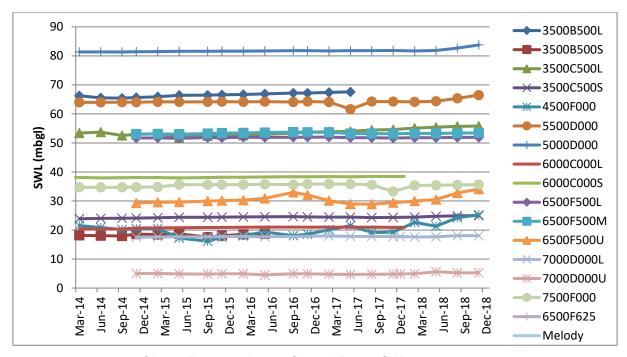
The results of monitoring SWL (measured in metres below ground level [mbgl], EC and pH from 2014 to 2018 for the groundwater central bores are shown in Charts 25, 26 and 27 respectively.

Chart 25: Groundwater Central Bores SWL 2014 - 2018

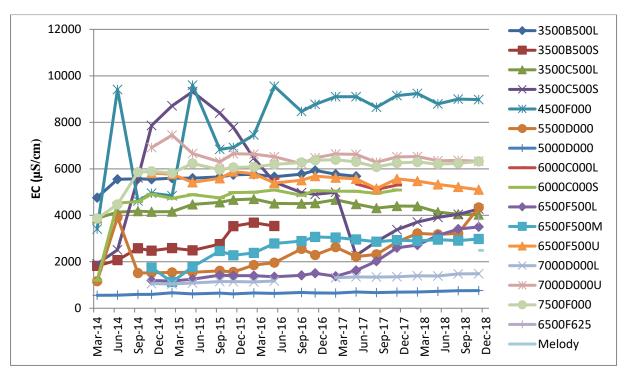
Chart 26: Groundwater Central Bores EC 2014 - 2018

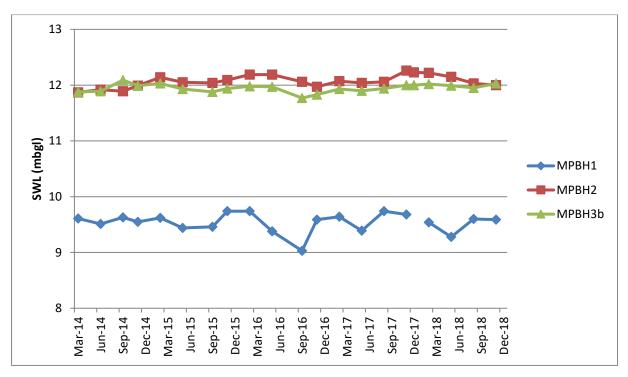
The results of monitoring SWL, EC and pH from 2014 to 2018 for the groundwater eastern bores are shown in Charts 28, 29 and 30 respectively.

Chart 28: Groundwater Eastern Bores SWL 2014 - 2018

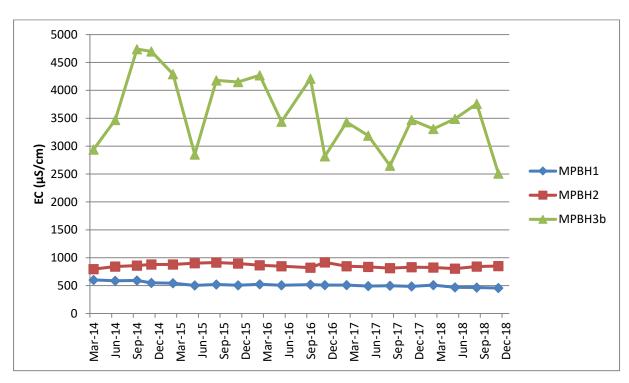
Chart 29: Groundwater Eastern Bores EC 2014 - 2018

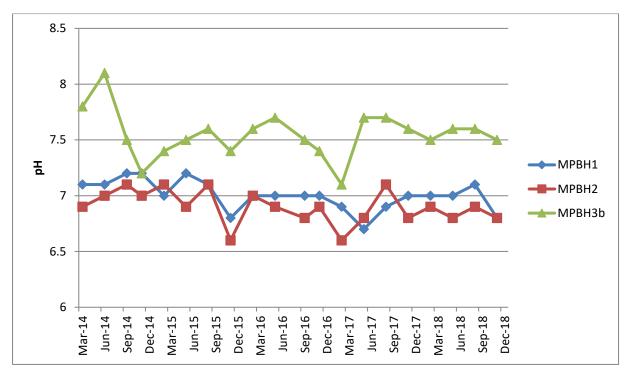
Chart 30: Groundwater Eastern Bores pH 2014 - 2018

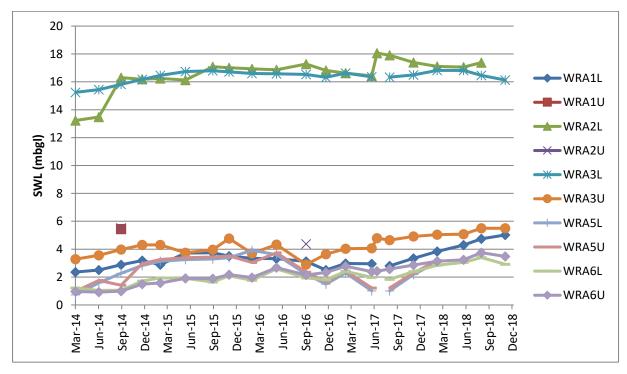
The results of monitoring SWL, EC and pH from 2014 to 2018 for the groundwater western bores are shown in Charts 31, 32 and 33 respectively.

Chart 31: Groundwater Western Bores SWL 2014 - 2018

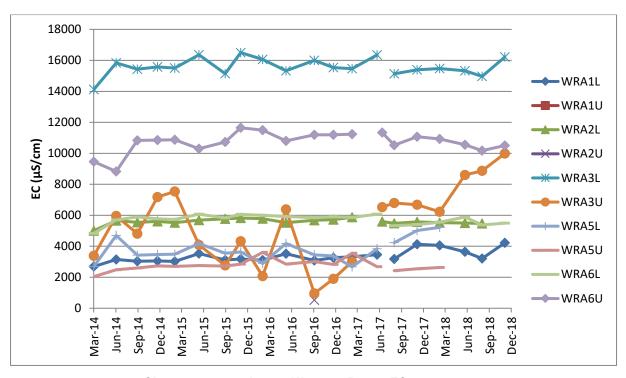
Chart 32: Groundwater Western Bores EC 2014 - 2018

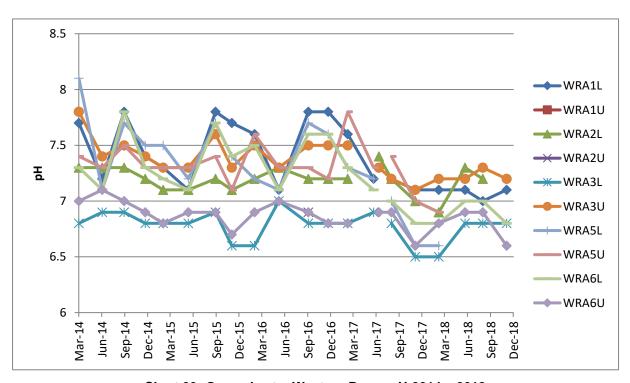
Chart 33: Groundwater Western Bores pH 2014 - 2018

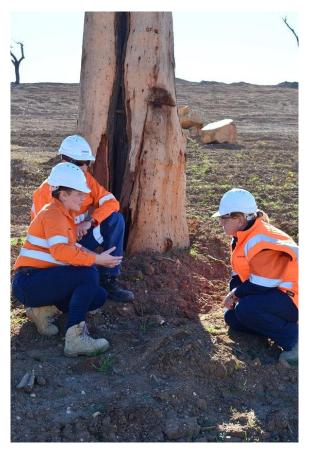
- topsoil spreading to a minimum depth of 100 mm;
- planting of approximately 1,000 trees per hectare; and
- hand seeding of cover crop (Japanese millet 5 kilograms per hectare [kg/Ha], Oats 3 kg/ha and Couch 1 kg/Ha).

Gypsum was also applied at a rate of 10 tonnes per hectare (t/ha) following topsoil spreading. Additionally, three habitat trees and two rockpiles were also installed during the reporting period.

Plate 2: 2018 Pit A Out of Pit Emplacement Rehabilitation
