Subject: Historic Heritage Management Plan

MOUNT PLEASANT OPERATION HISTORIC HERITAGE MANAGEMENT PLAN

Document ID:	MP001-0000-ENV-PLN-0019		
Company:	MACH Energy Australia Pty Ltd		
Effective Date:	6 June 2025	Status:	Issued For Use
Approved By:	Lisa Richards	Revision Number:	02

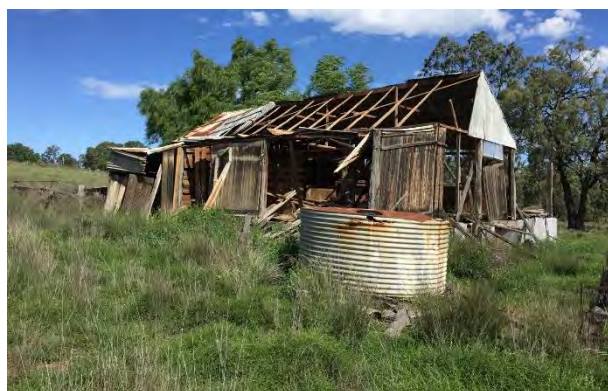
Figure 9. The damaged remains of the shearing shed at Thorndale (MP27) in early 2019 (Source: MACH 2019 in Extent Heritage 2020, p. 93).

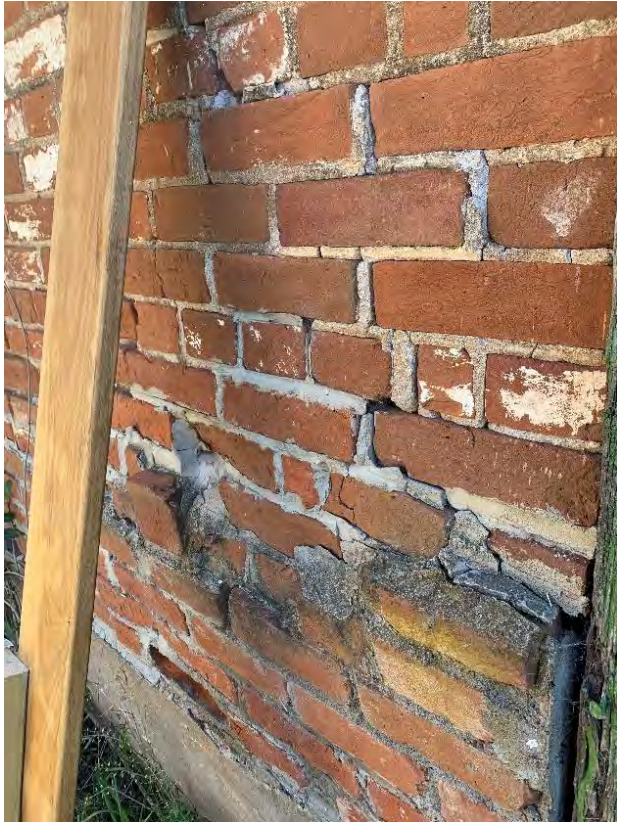
Figure 15. The cracking and bulging of brickwork typical at Negoa, resulting from ground movement. Note the previous cement mortar repairs are failing. Photograph taken September 2020.

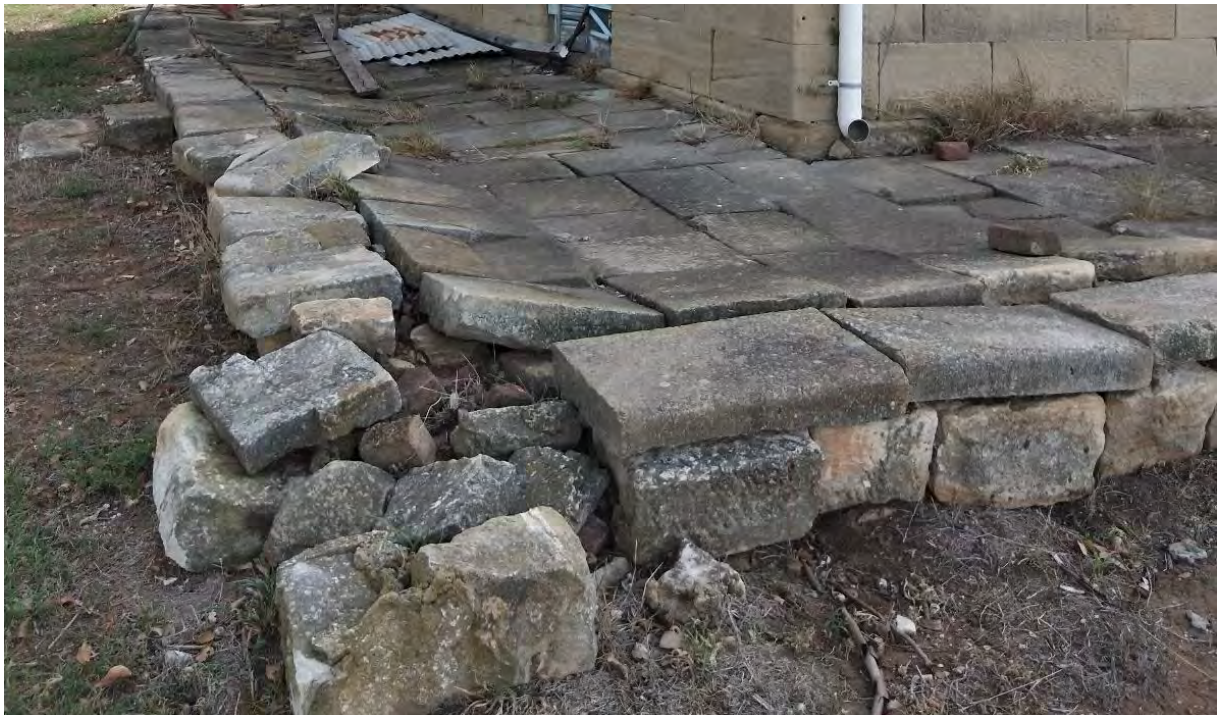
Figure 16. The failed stone paving on west and north elevations of the c.1850s–60s sandstone section of Negoa. Photograph taken April 2018.

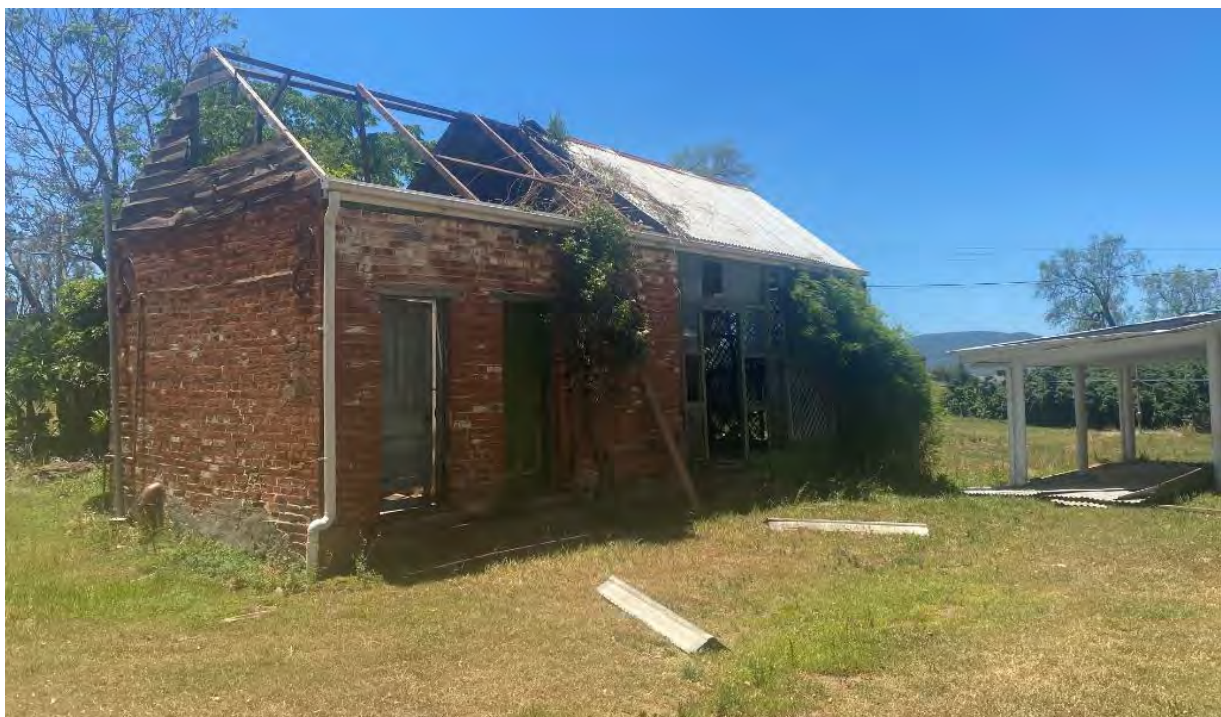
Figure 22. The servants' quarters, showing some of the damage sustained to the roof as a result of a storm event in December 2020.

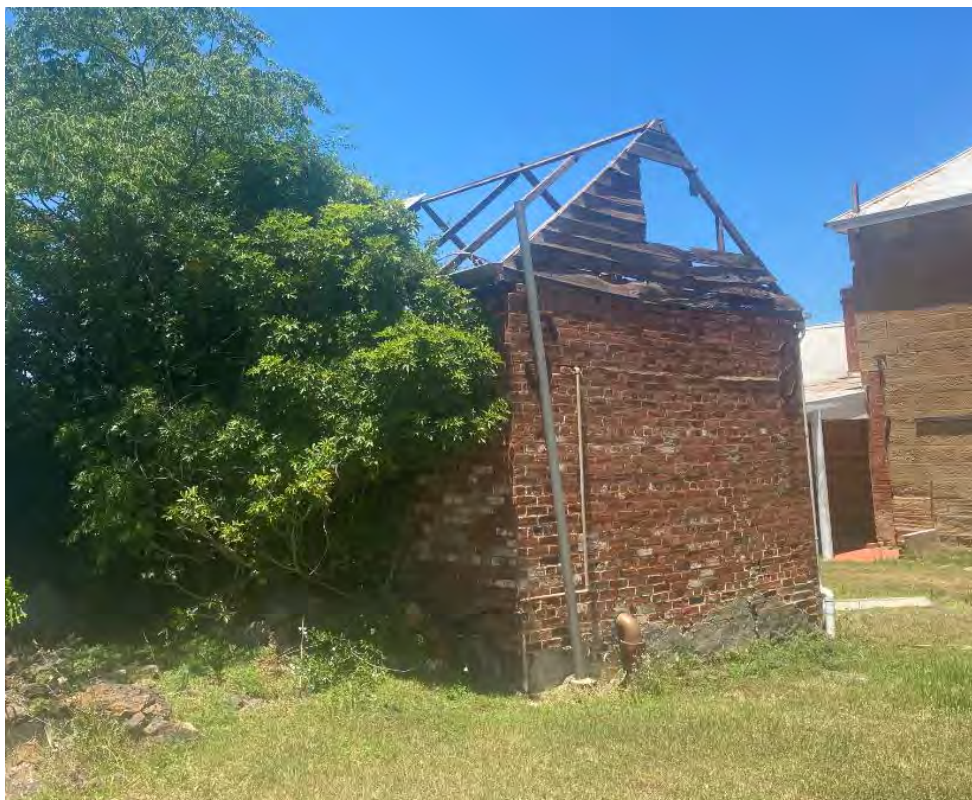
Figure 23. The western elevation of the servants' quarters, showing the damage sustained to the roof as a result of a storm event in December 2020.

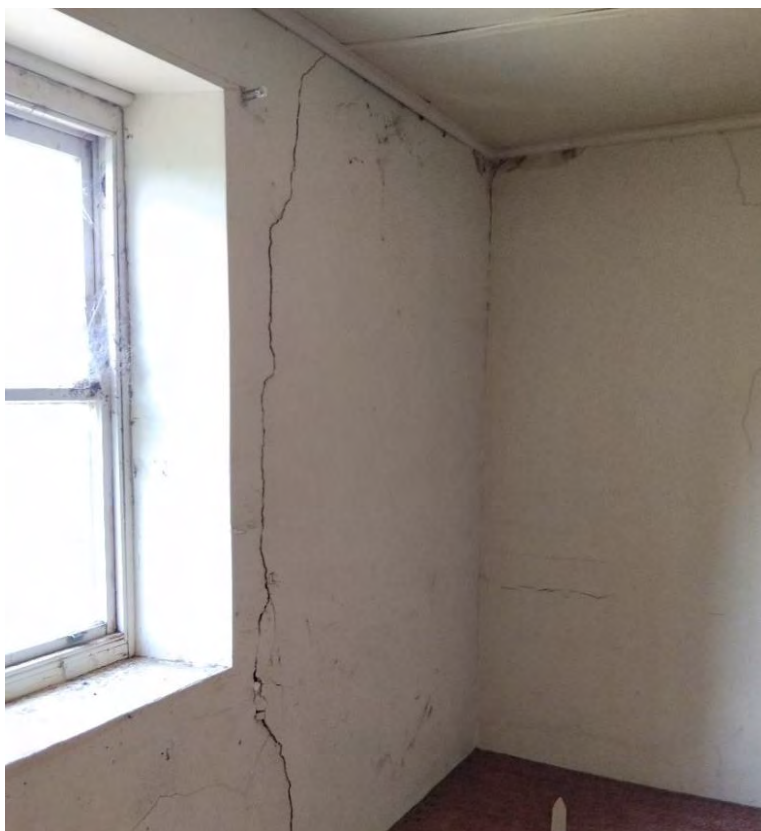
Figure 29. Interior view of one of Negoa's rooms, showing possible structural cracking typical in the internal walls of the c.1850s–60s sandstone section. Photograph taken April 2018.

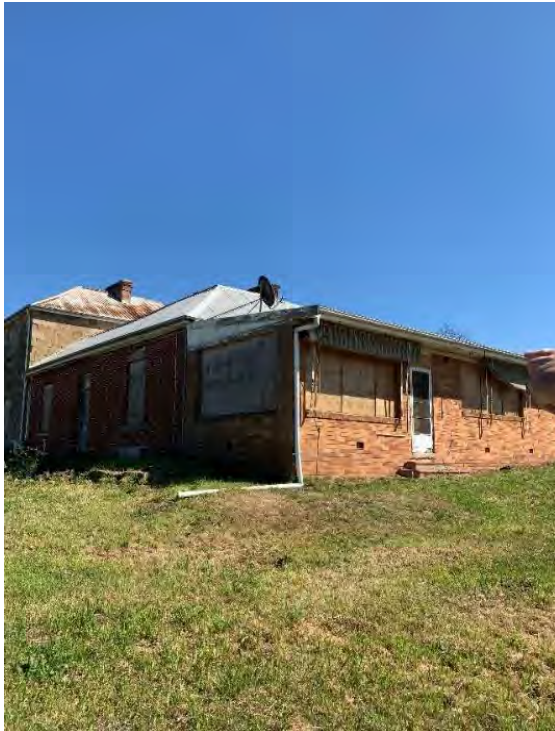
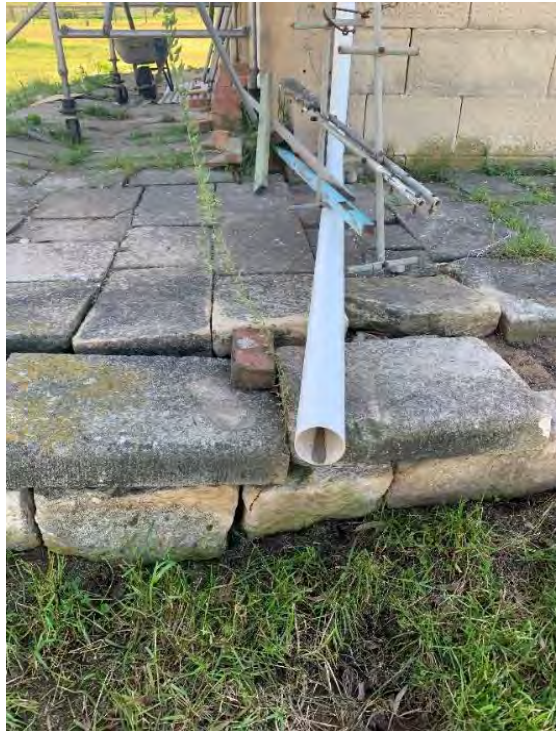
Figure 30. The downpipes have been extended to carry water away from the walls, footings and stone paving around the homestead's structures

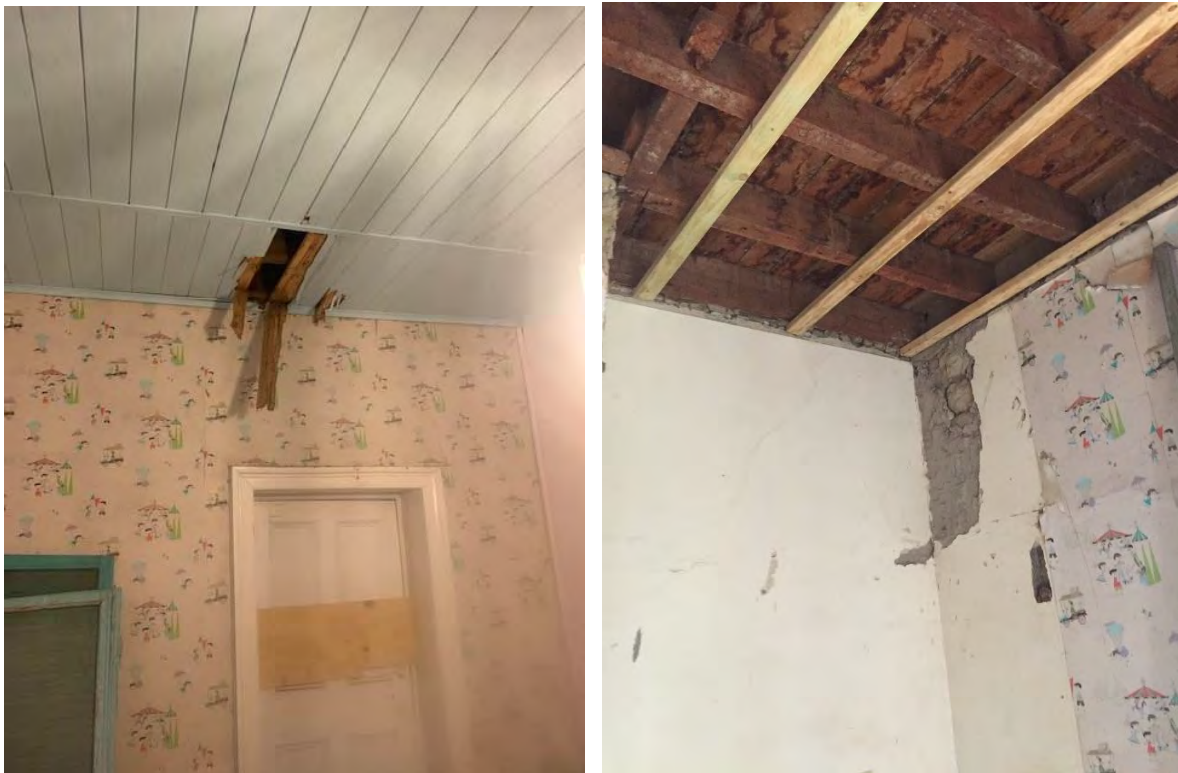
Figure 33. Details of the termite-damaged ceiling removed from the downstairs bedroom.

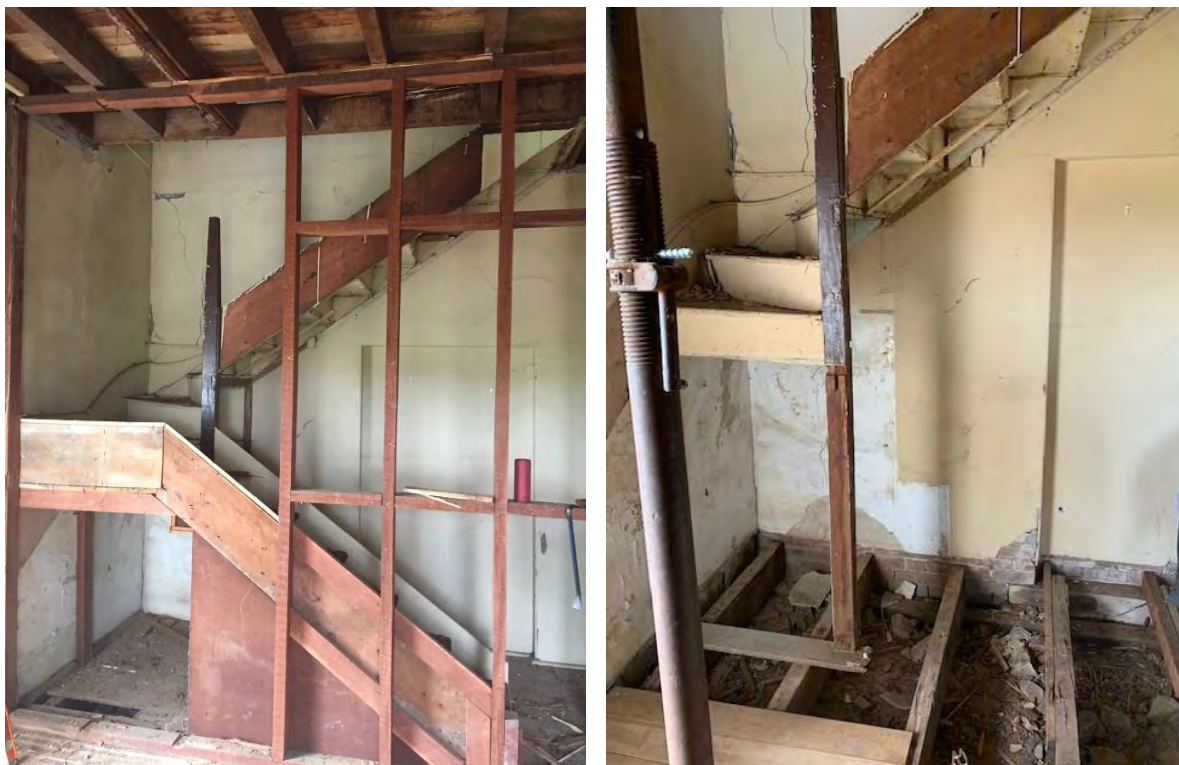
Figure 34. Detail of the termite-damaged timber stairs, since removed and reconstructed.

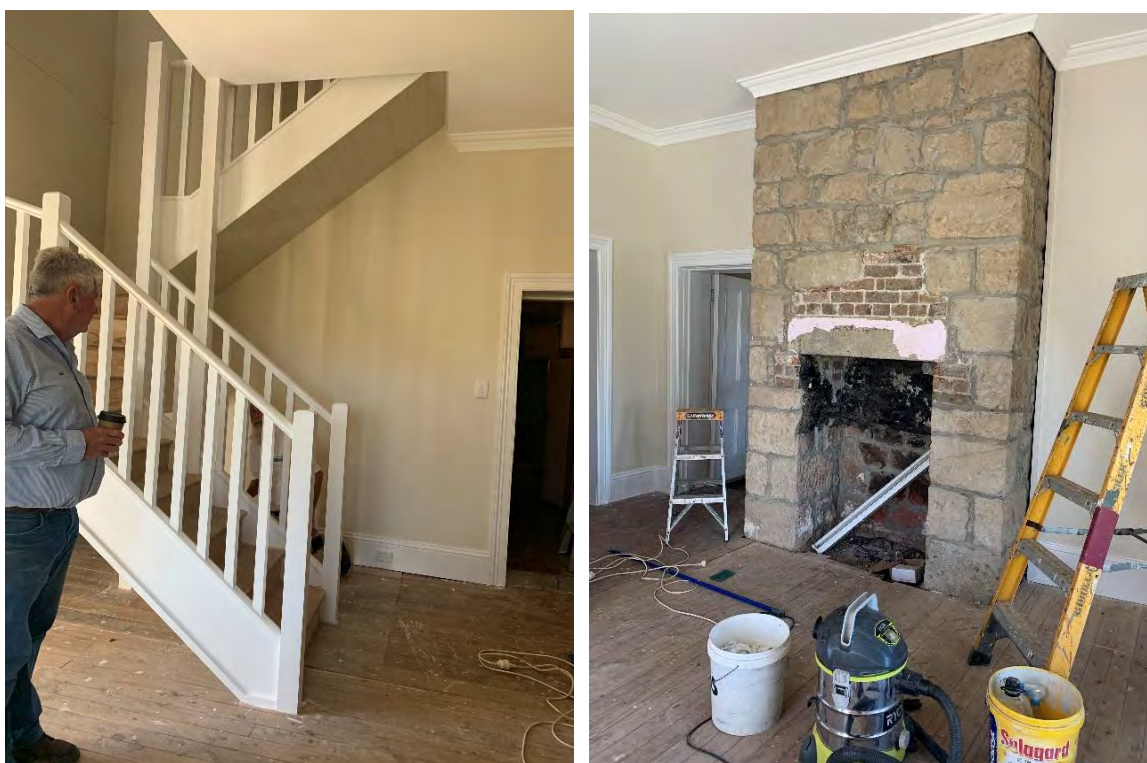
Figure 35. Left: The reconstructed internal stair. Right: The exposed stone chimney breast in ground floor bedroom.

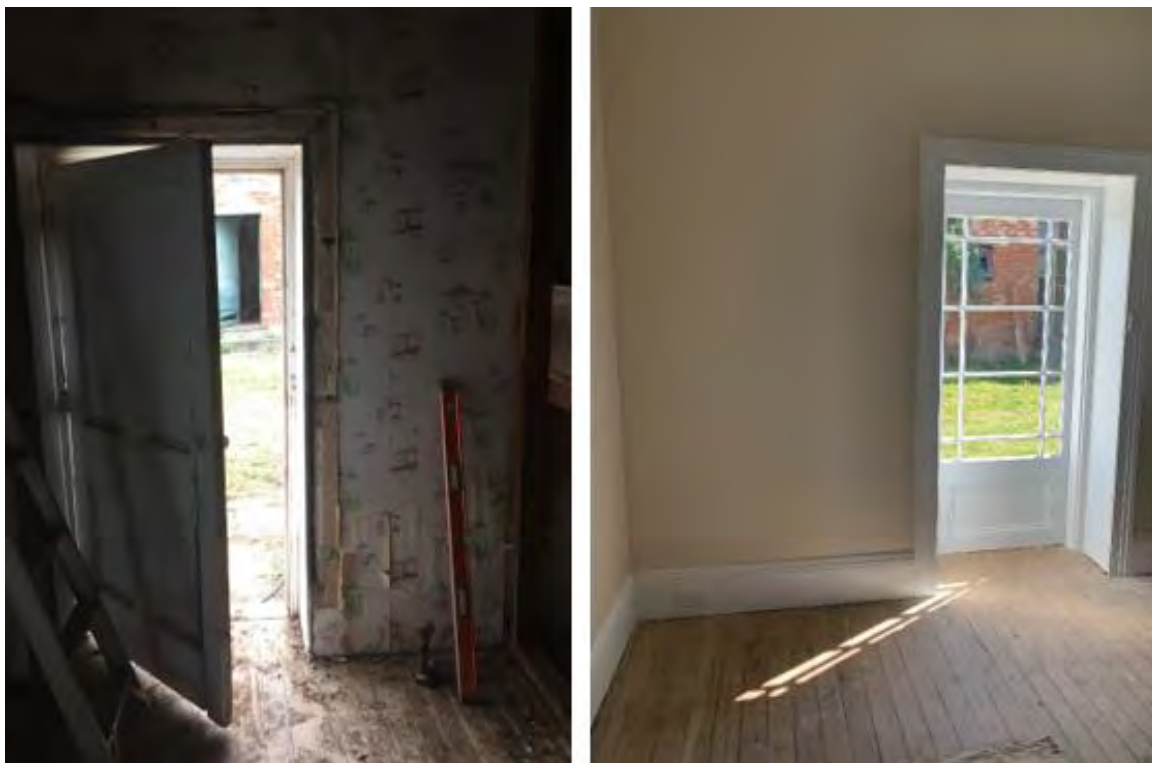
Figure 36. Left: The original four-panel entry door, which has been removed. Right: The replacement half-glazed door with margin glazing.

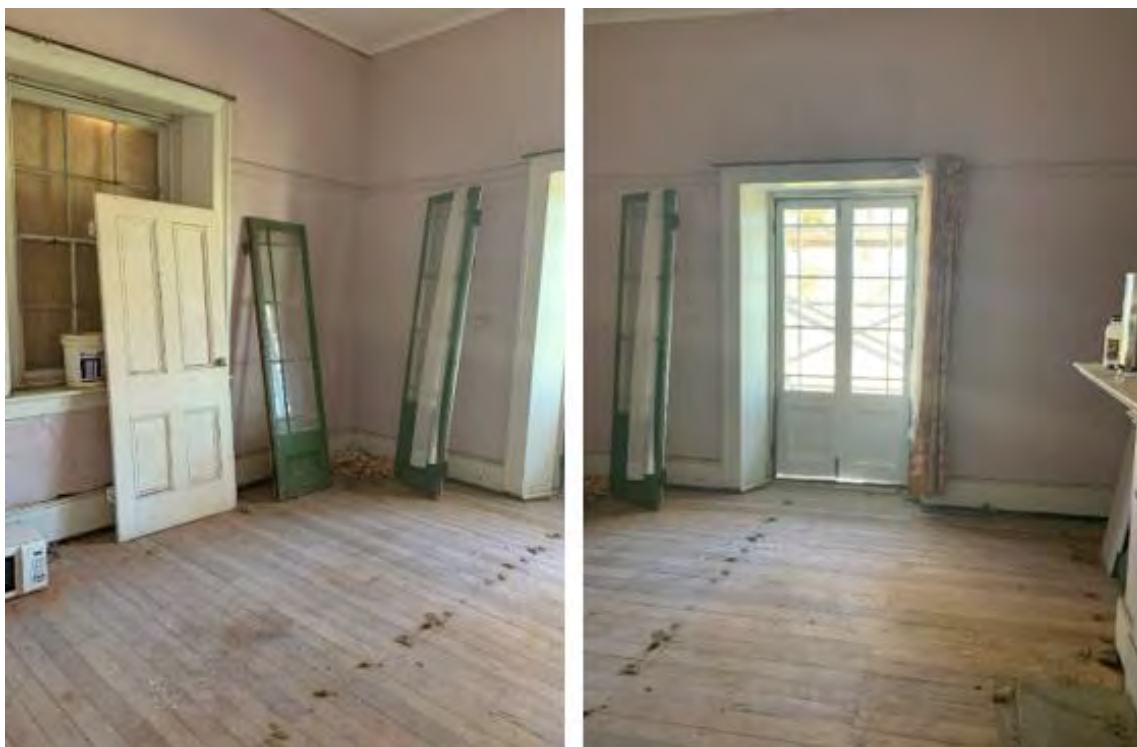
Figure 37. Left: The removal of the existing French doors. Right: The reinstatement of new doors reconstructed to the original profile.

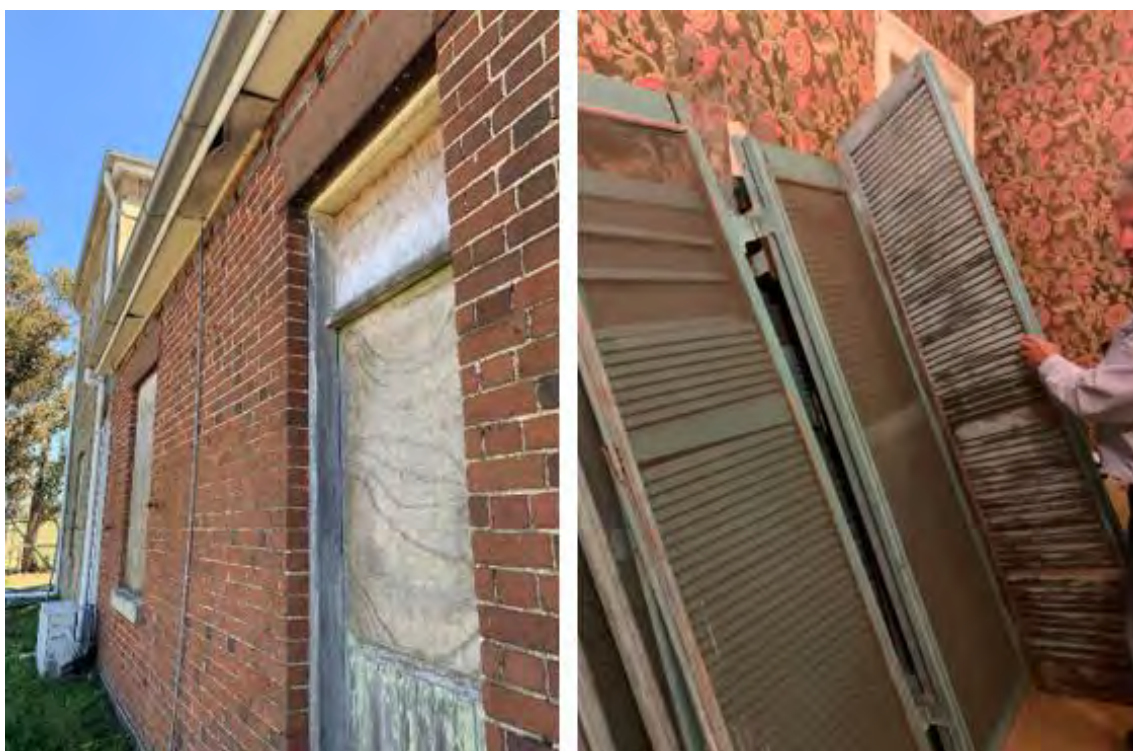
Figure 39. Left: The existing external shutters have been removed, and door and window openings along the southern elevation have been boarded with plywood sheets. Right: The removed external shutters stored inside for repair window.

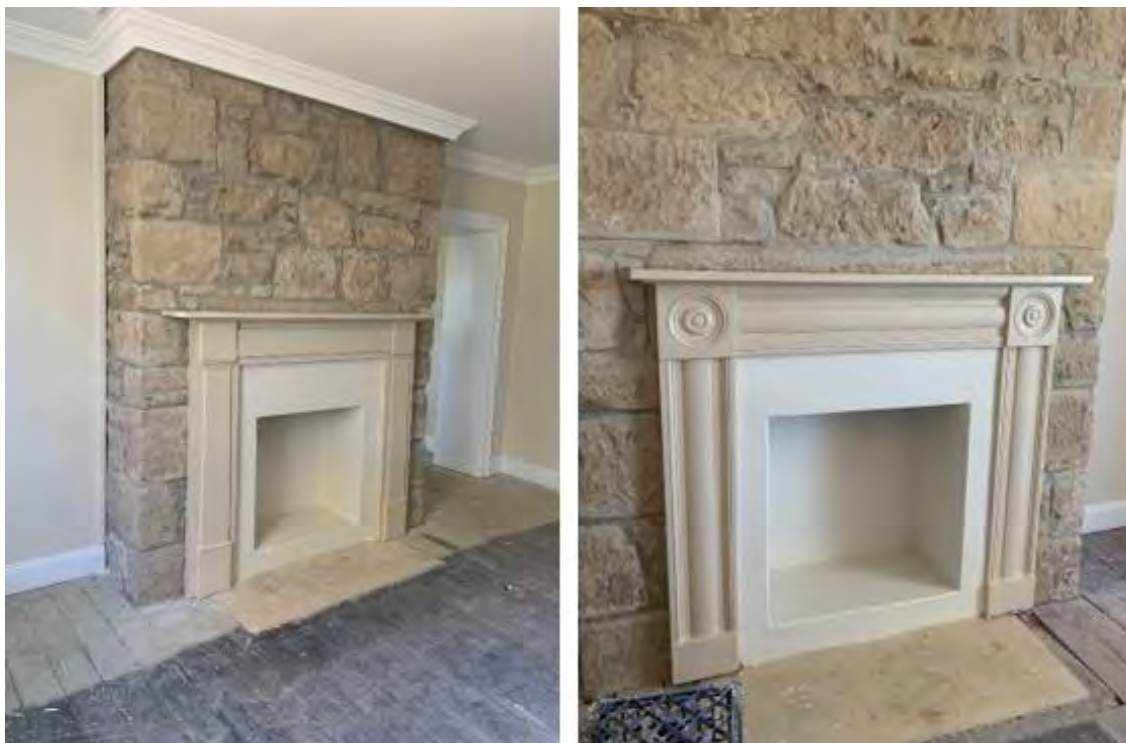
Figure 40. The exposed repointed stone chimney breast and reinstated fireplace and mantelpieces in the upstairs bedrooms.

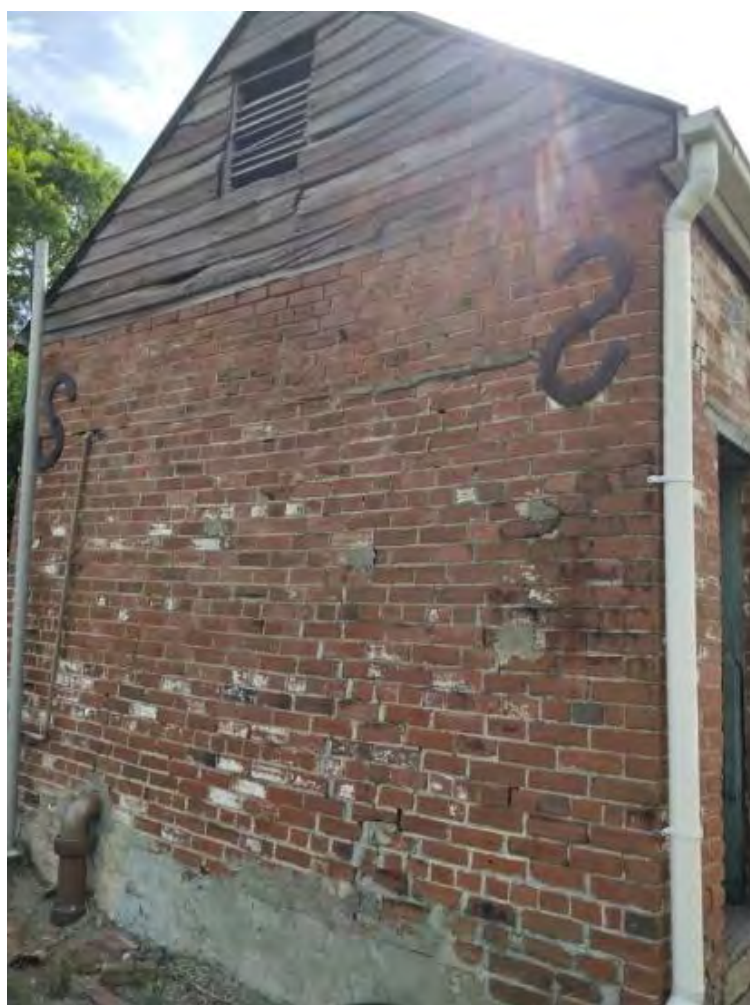
Figure 45. The western elevation of the servants' quarters outbuilding. Note the cement-based repair work. Do *not* employ this method of repair in future. Where possible without inflicting further structural damage, reverse where it has occurred by raking out joints and repointing with lime mortar.

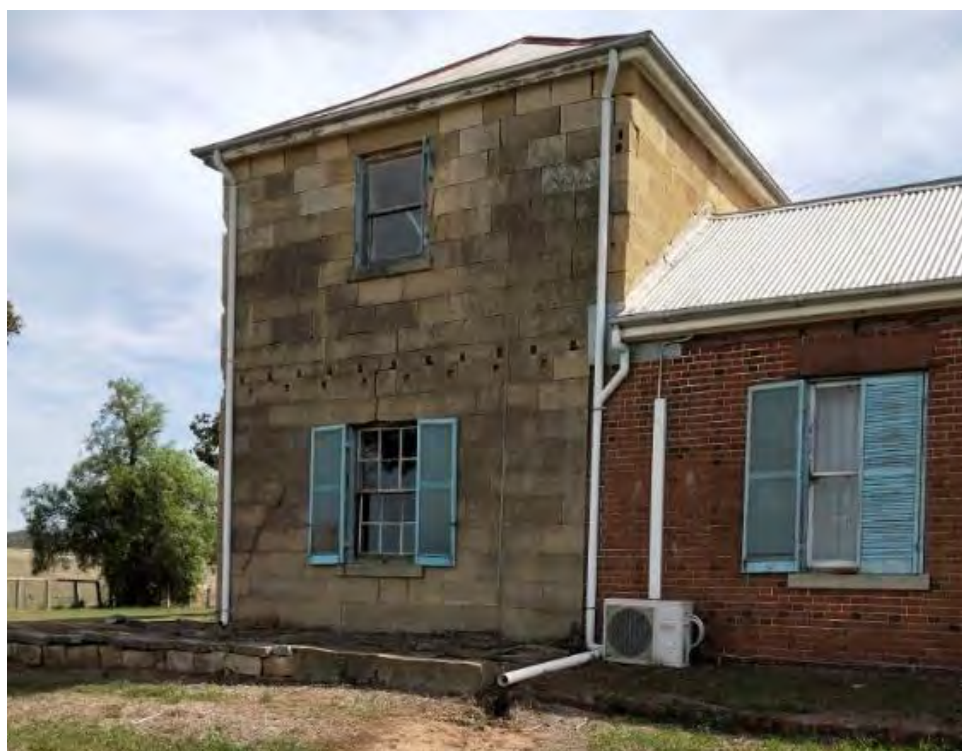
Figure 47. The white downpipes and air conditioning materials detract from the aesthetic appearance of the southern elevation. The air conditioners should be removed and the downpipes replaced with galvanised ones.

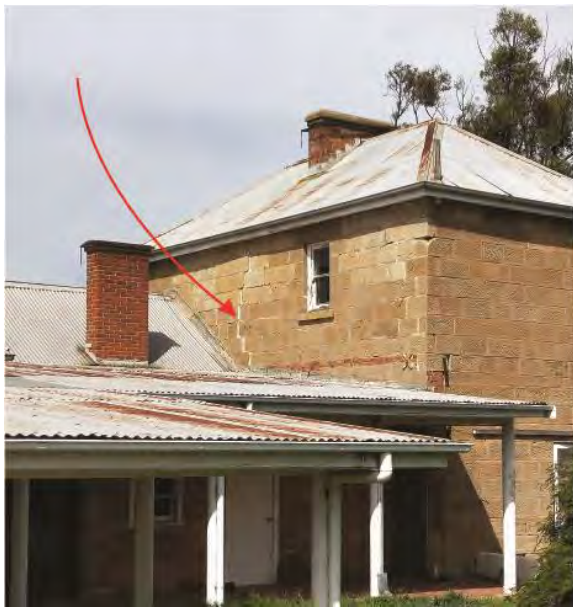
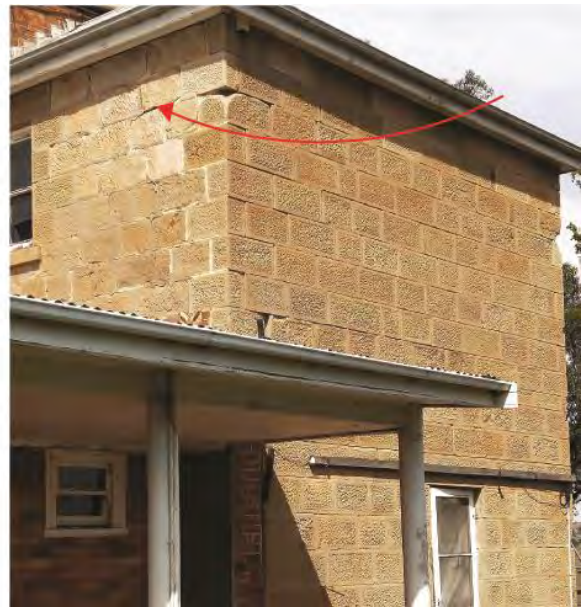
Figure 50. The eastern and northern elevations of Negoa comprising sandstone, showing the cracks in the stonework and the abraded stones (red arrows). The causes must be investigated and repairs undertaken.

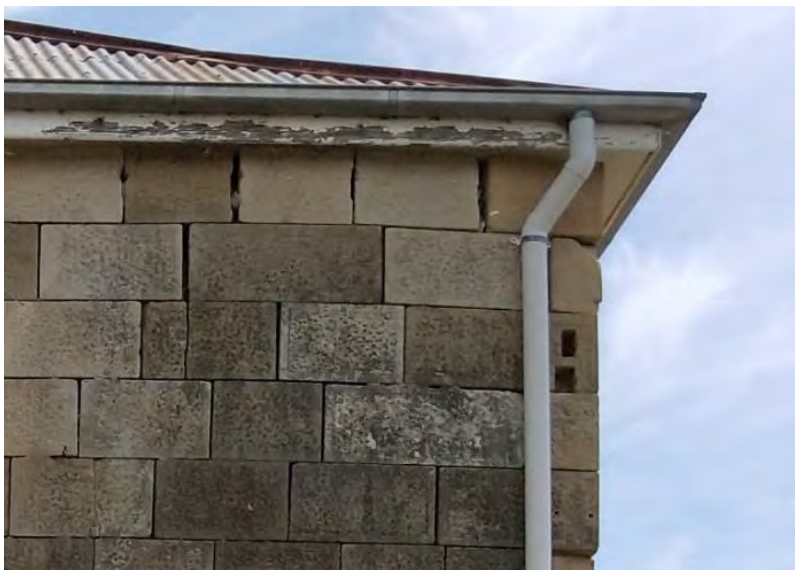
Figure 51. Southern elevation of the sandstone section of Negoa, showing damage to the upper courses of stonework caused by building movement. The causes are to be investigated and the stones reset.

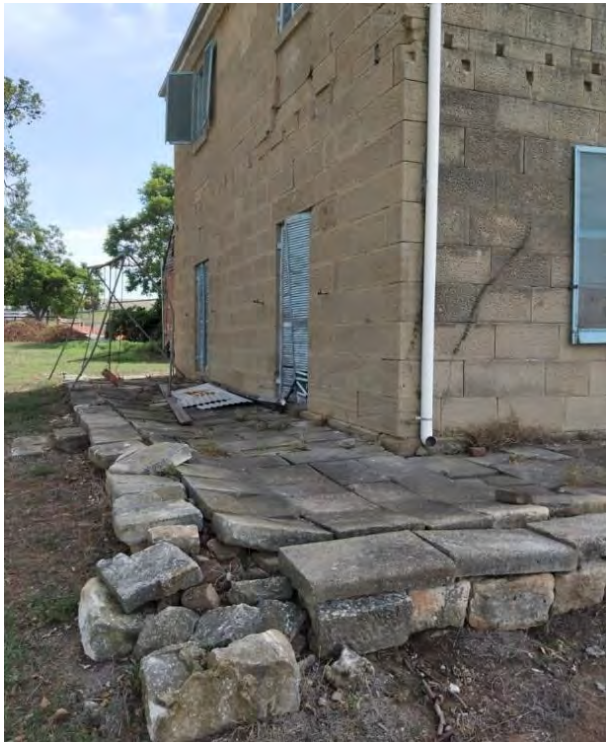
Figure 52. A section of the failing stone paving on western and northern elevations of the sandstone section of Negoa.
